**DEPARTMENT OF TRANSPORTATION****DIVISION OF ENGINEERING SERVICES**

Contract #: 04-0120F4Cty: SF/ALA Rte: 80 PM: 13.2/13.9File #: 69.28**WELDING INSPECTION REPORT****Resident Engineer:**Siegenthaler, Peter**Address:** 333 Burma Road**City:** Oakland, CA 94607**Report No:** WIR-021348**Date Inspected:** 07-Feb-2011**Project Name:** SAS Superstructure**OSM Arrival Time:** 700**Prime Contractor:** American Bridge/Fluor Enterprises, a JV**OSM Departure Time:** 1900**Contractor:** Zhenhua Port Machinery Company, Ltd (ZPMC), Changxing Island **Location:** Shanghai, China**CWI Name:** Lv Li Qing**CWI Present:** Yes No**Inspected CWI report:** Yes No N/A**Rod Oven in Use:** Yes No N/A**Electrode to specification:** Yes No N/A**Weld Procedures Followed:** Yes No N/A**Qualified Welders:** Yes No N/A**Verified Joint Fit-up:** Yes No N/A**Approved Drawings:** Yes No N/A**Approved WPS:** Yes No N/A**Delayed / Cancelled:** Yes No N/A**Bridge No:** 34-0006**Component:** OBG**Summary of Items Observed:**

BAY # 14

OBG 14EAST

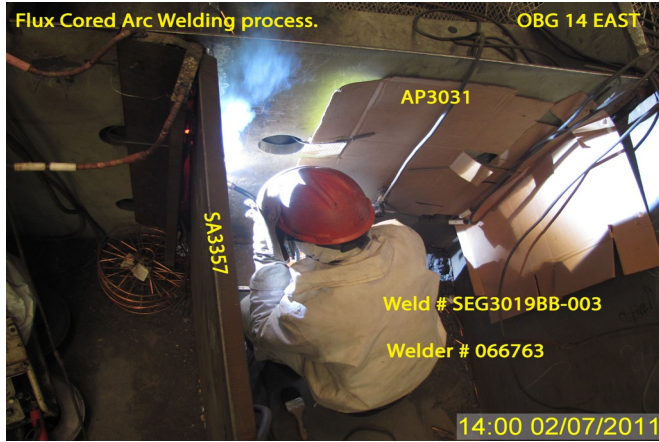
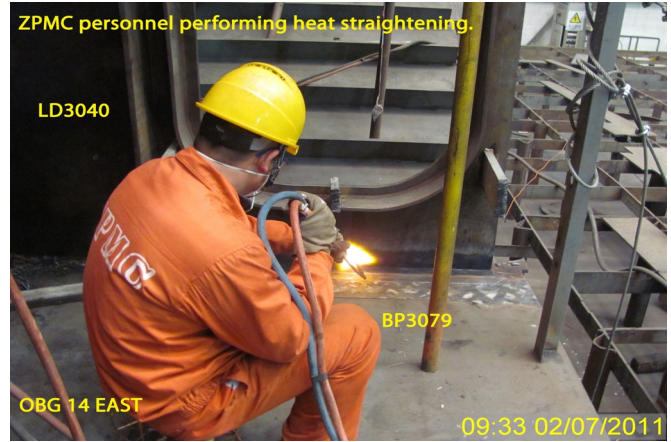
This Quality Assurance (QA) Inspector observed ZPMC qualified welder 215553 performing the Shielded Metal Arc Welding process on weld 037 located at PCMK SEG3019BB. ZPMC QC Mr. Guo Xing Hui was monitoring this welding operation. The welding variables recorded by QC appeared to comply with WPS-345-SMAW-2G (2F)-Fcm-Repair-1. Critical weld repair report identified as B-CWR2737.

This Quality Assurance (QA) Inspector observed ZPMC personnel performing heat straightening, member identified as bottom panel (BP3079) and longitudinal diaphragm (LD3040). Distortion appeared to be caused by welding. ZPMC Quality Control (QC) inspector identified as Mr. Xie Ming Feng was present to monitor the heat straightening process. The heat straightening appeared to comply with heat straightening Report HSR1 (B)-09979.
